Pentium® III Xeon™ Processor Specification Update

Release Date: January 2000

Order Number: 244460-010

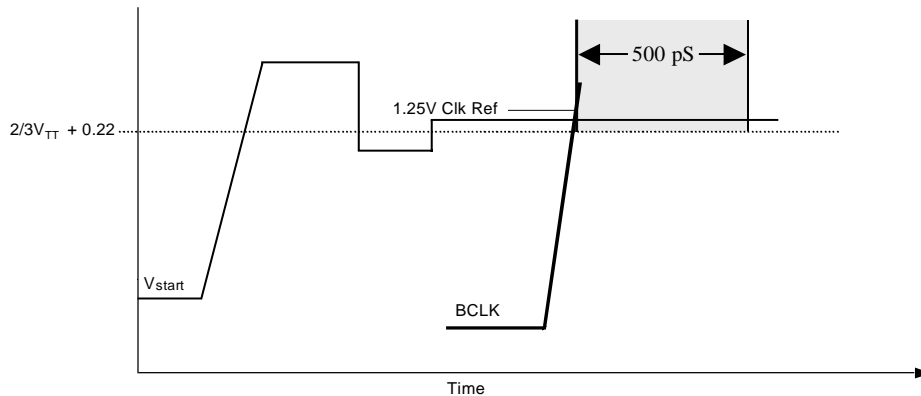
The published AGTL+ AC specification for $V_{IH(MIN)}$ is $(2/3 \cdot V_{TT}) + 0.1$ Volts.

Intel has characterized the new AGTL+ AC specification for $V_{IH(MIN)}$ on the processor's RS0# signal to be: $(2/3 \cdot V_{TT}) + 0.22$ Volts within 500 picoseconds following the rising edge of BCLK crossing the 1.25-Volt threshold. See below.

Implication: The deviation from the published specification results in decreased noise margin on the RS0# processor input. This decreased noise margin has been observed to be particularly detrimental in system environments where the RS0# processor input is being driven by an I/O buffer with a pull-up device (such as a p-channel transistor) that is switched off mid-cycle. Systems which employ I/O buffers that keep the pull-up device on for the entire cycle are significantly less affected by this erratum. The reduction in noise margin may lead to the generation of BINIT# (when enabled) resulting in a system reset, otherwise this condition may lead to a system "hang" condition.

Workaround: If a system design cannot meet the specification deviation, the following areas should be carefully examined to assure that additional margin exists in order to compensate for any deficit observed with respect to the newly characterized $V_{IH(MIN)}$ specification:
